# Technical Memorandum

## Bank Protection at Pancake Point and Welcome Slough, Puget Island

**Wahkiakum County**

October 31, 2003

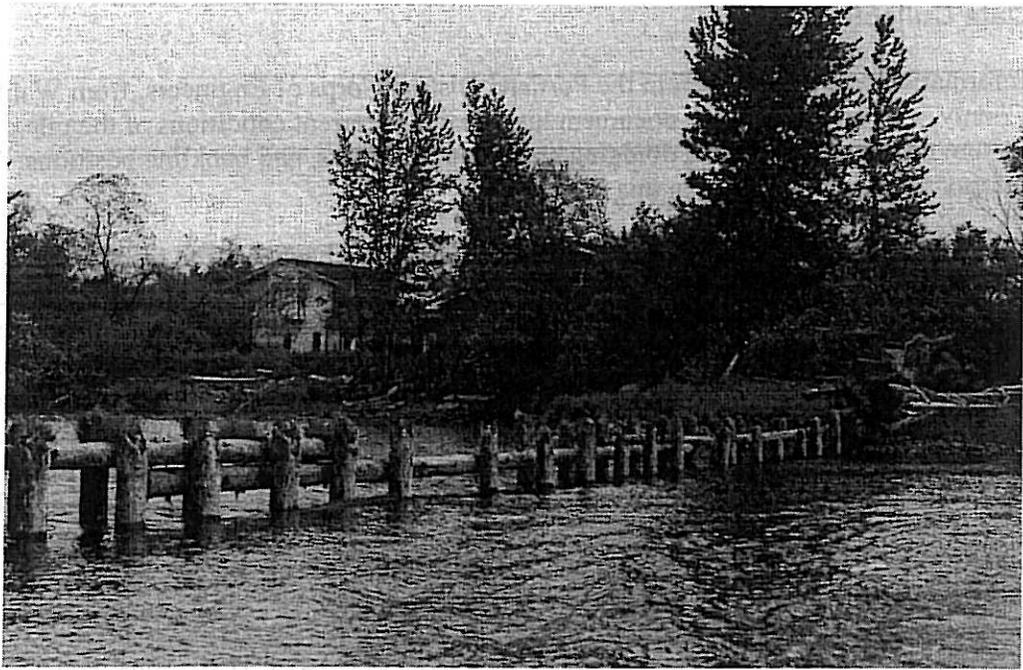
Both sites of most critical erosion are on the downstream side of pile dikes. Figures 2 and 3 are photographs of the Welcome Slough and Pancake Point erosion sites, respectively. Shoreline loss due to erosion at least at shallow depth is evident at the pile dike landward end at the two locations. A concave bend in the bankline centered where the pile dike connects to land, present at the two sites, is a common feature observed in association with pile dikes on the lower Columbia River. Sudden slumping of a section of the bankline into the river has been reported just downstream of the pile dike at both study sites. A loss of several feet of bank was experienced suddenly on April 27, 2002 at Pancake Point. This mode of loss suggests slope instability due to oversteepening as a failure mechanism, and erosion at depth adjacent to the bank is a factor in the bankline loss.

**Figure 2** Bank erosion downstream of pile dike 40.51 (Welcome Slough)

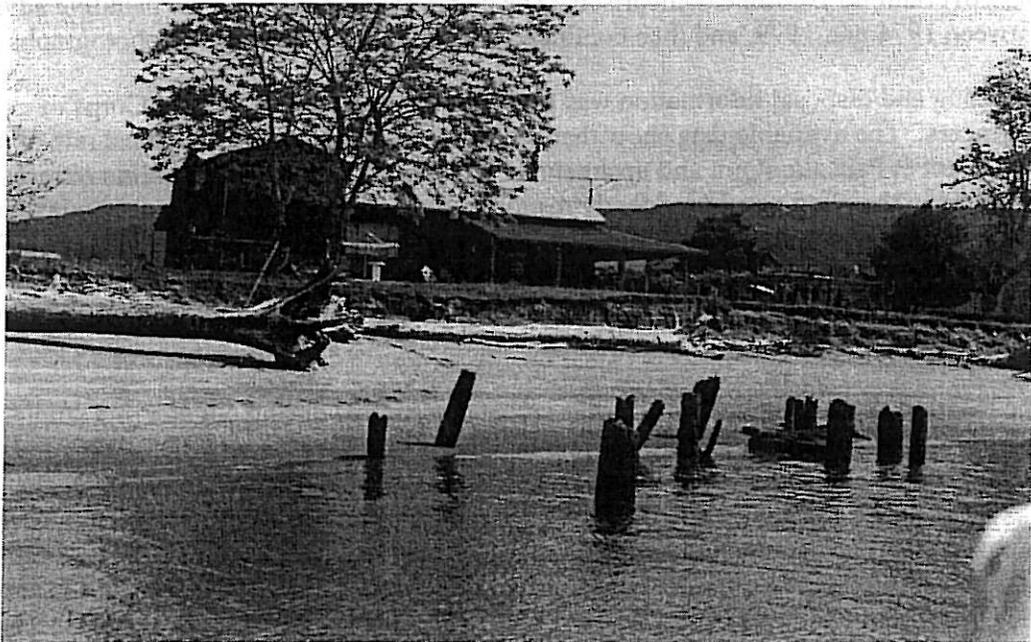
**Figure 3** Bank erosion downstream of pile dike 43.55 (Pancake Point)

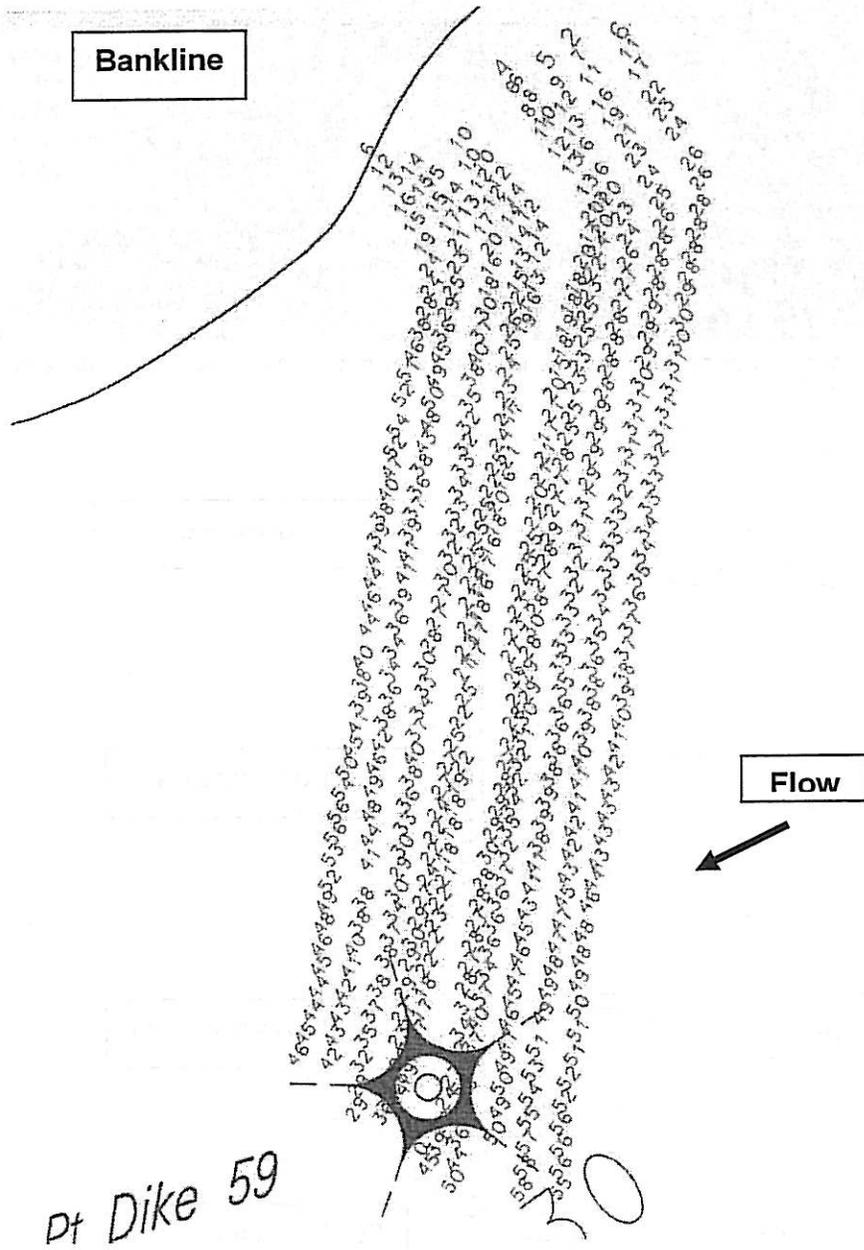
Bottom depths in the vicinity of the problem areas are not well documented. Cross line surveys have not covered the areas subject to erosion. A swath survey close to the pile dike 43.55 was completed in 2002, and is shown in Figure 4. Cross sections spaced at 25 feet increments downstream of the dike are shown in Figure 5. A sequence of 4 bottom profiles is shown in Figure 6.

Figure 4 Hydrographic survey at pile dike at Pancake Point

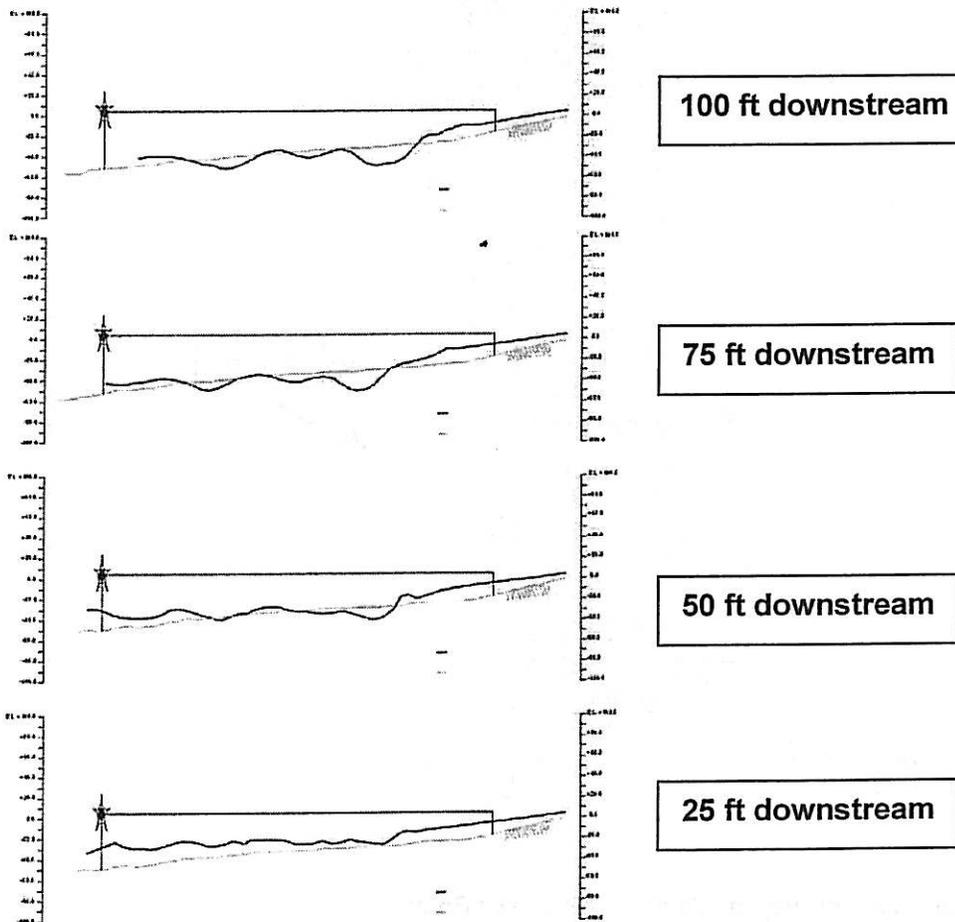
Figure 6 Bottom profiles at successive distances downstream from pile dike at Pancake Point

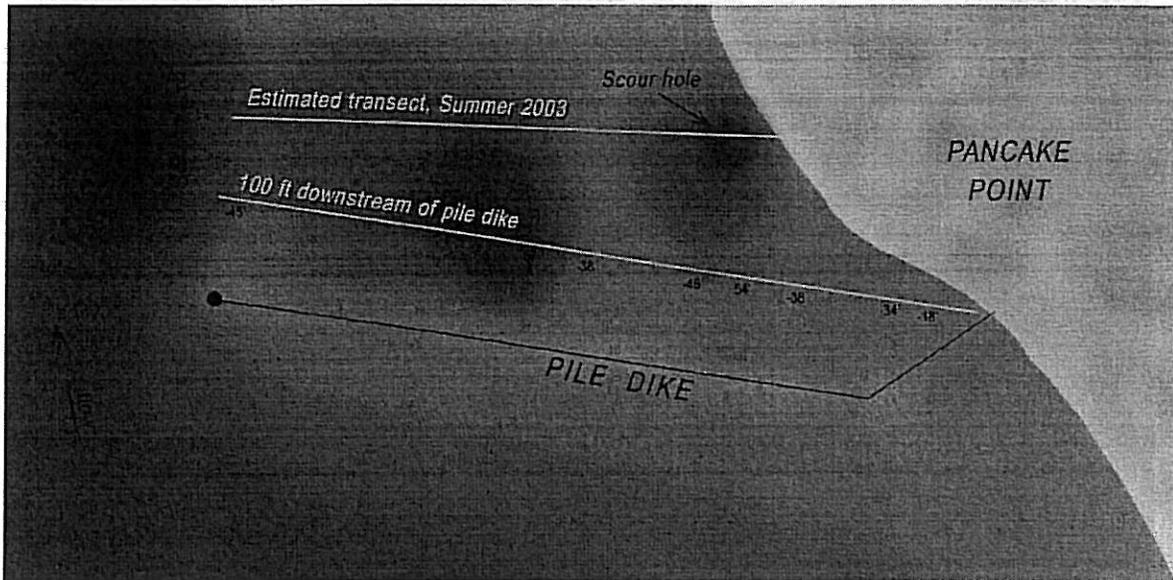
An informal measurement of depth was made in May 2003 using an acoustic depth sounder mounted on a small boat and positions at which depths were recorded were visually estimated from reference points. The pattern of bottom profiles shows that a scour hole exists downstream of the pile dike and is within 100 feet of the bank at Pancake Point. A diagram interpreting the combined depth information is shown in Figure 7.

Figure 7 Interpretation of scour hole locations based on depth information

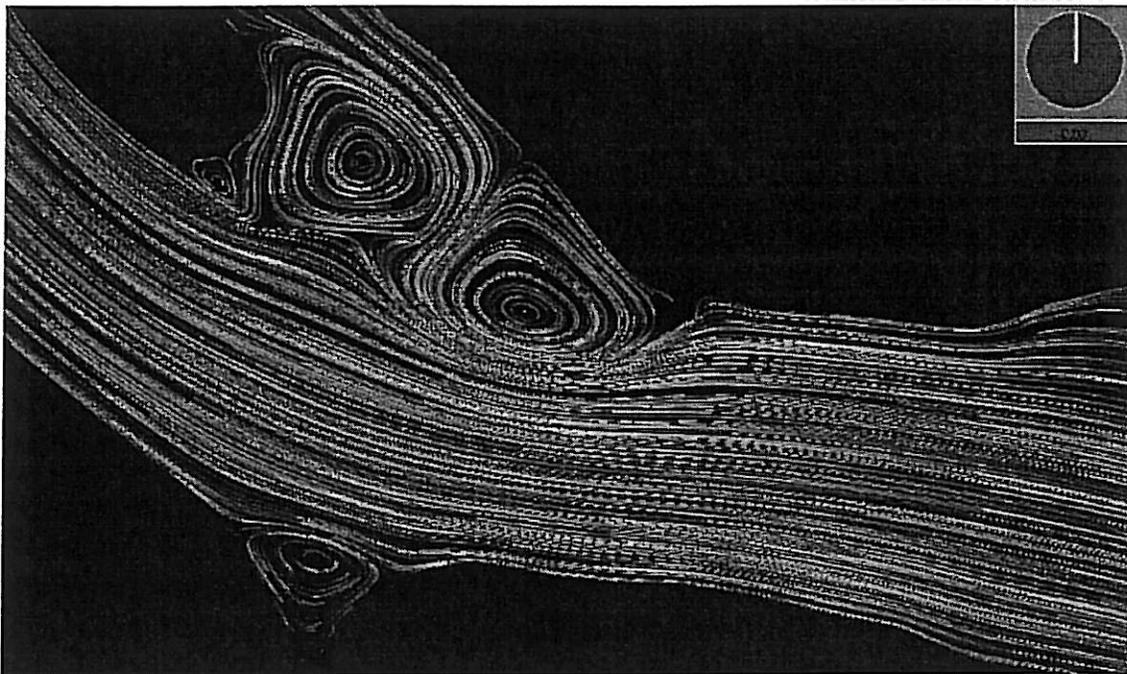
As a demonstration of possible effects of a pile dike on flow patterns, a generalized model of river flows was developed for two cases. One case represents a portion of the Wauna and Driscoll Ranges before pile dikes were constructed at Pancake Point. The second case represents the same location and river discharge with pile dikes in place. Model results of a 200,000-c.f.s. discharge and a dike having low porosity are shown in Figures 8 and 9. Comparison of the figures indicates that the pile dike at Pancake Point is capable of flow interference of the type that could create an eddy turning in the observed direction. Although the pile dike near Welcome Slough was not modeled with the generalized hydraulic model, cause-and-effect relationship of the presence of the pile dike and lack of

sand placement with development of a deep scour hole near the bank is likewise inferred at this location.

Figure 9 Flow pattern in approximated Wauna Reach with pile dikes represented
