#### IV. Identification of Flood Issues-Past and Present

##### A. Record of historic flood events

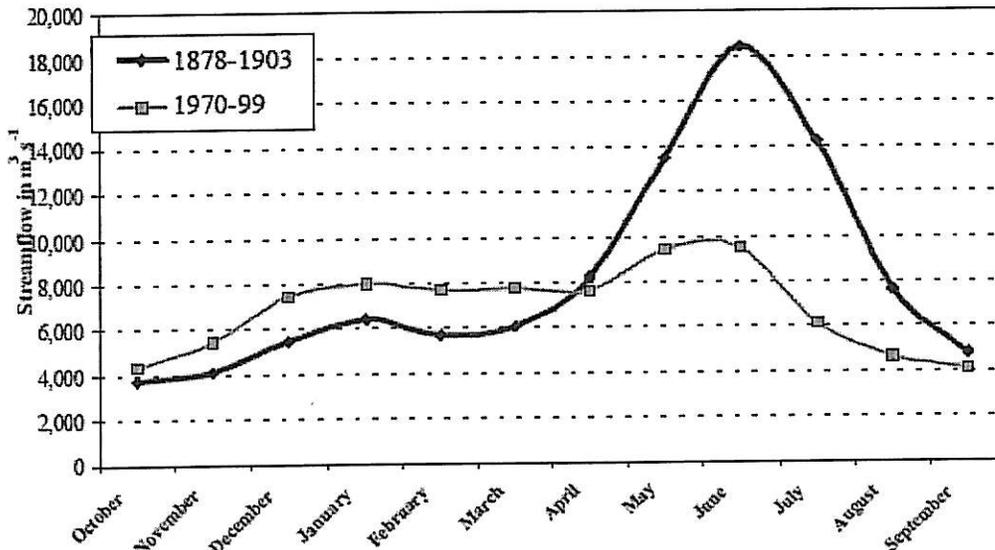
Figure 4.1 Columbia River Flow Patterns Comparison: Virgin vs. Modified Flow Patterns

The watersheds of Wahkiakum are in part a product of the conditions of the Lower Columbia River. Historically, high flow, spring freshets occurring in May-June would inundate the lower portions of Wahkiakum frequently reconfiguring networks of off-channel sloughs and wetland types. The construction of the Hydropower Dam System in the upper portions of the mainstem Columbia combined with irrigation withdrawals, has extensively altered the timing, intensity, and overall volume of water. Figure 4.1 demonstrates the effect these activities have had on the timing of freshets.

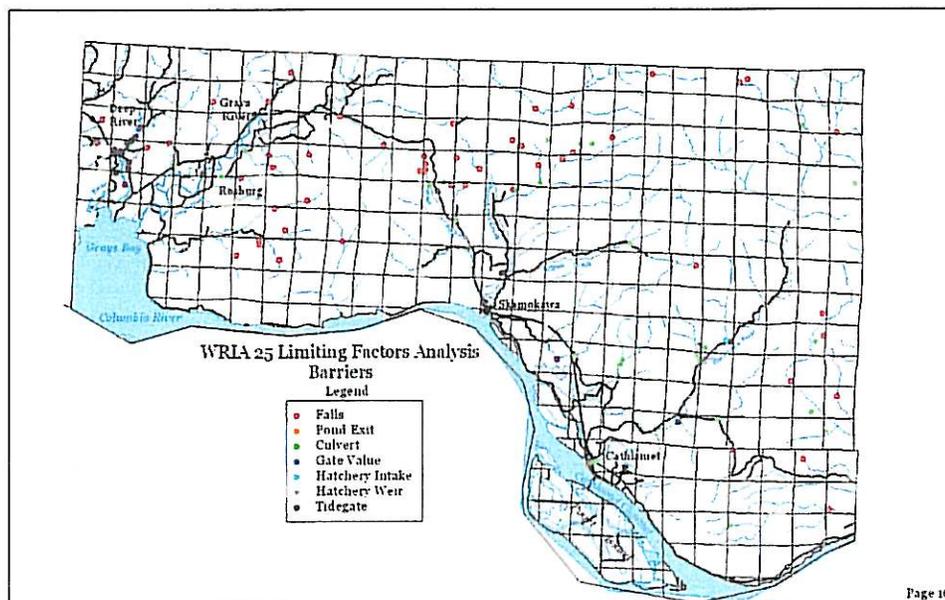
Figure 4.4: LFA Fish Barrier Inventory (map produced by CREST)

Specifically on the Grays River in 1940s and 50s, the Army Corps, in partnership with the County Conservation District investigated and implemented a variety of opportunities for streambank protection that included the placement of riprap, stone revetments, gravel dikes, gravel removal, etc. The Grays River Habitat District currently maintains these structures formerly the Upper Grays River Diking District. In addition, tidegates were installed in the lower areas of the Grays River area. More than 20 of these structures were constructed in both the Grays and Deep River area. A preliminary inventory shows the distribution of these structures and other barriers throughout the County.

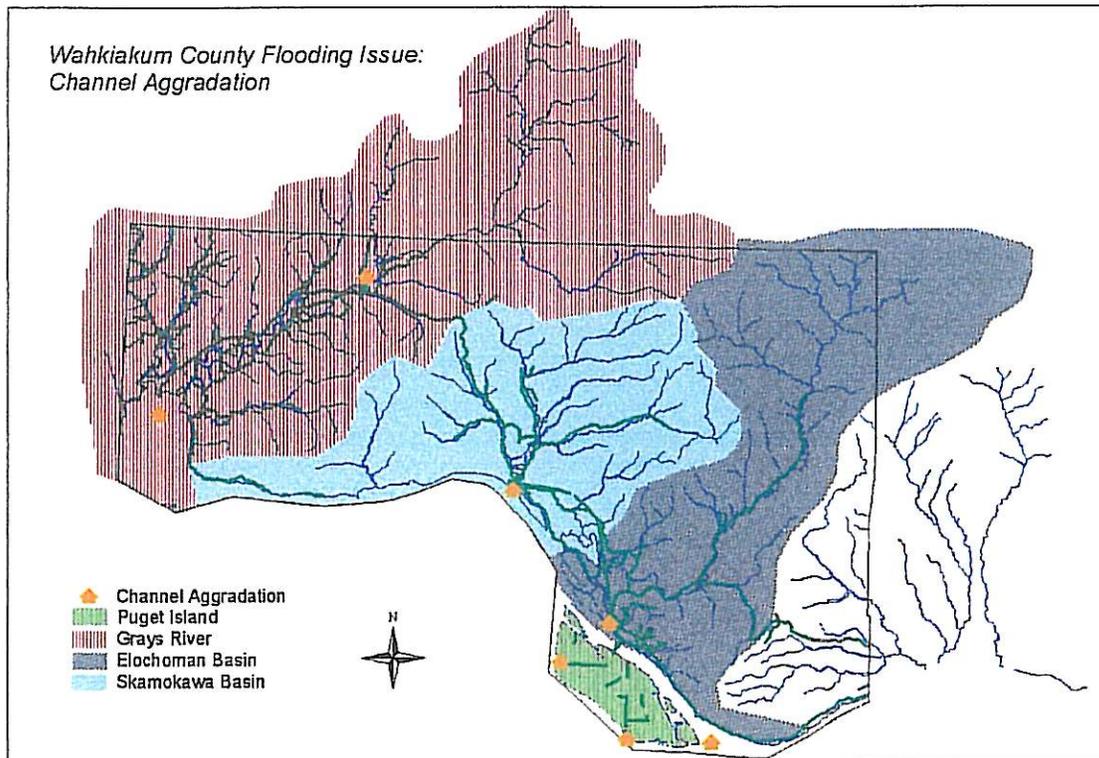
Figure 4.7: Areas of Channel Aggradation in Wahkiakum County

Erosion and aggradation are interrelated watershed processes that maintain floodplain equilibrium. Channel aggradation happens when a riverbed elevation is built up by the combination of sediment-flow dynamics identified in Chapter 3. Put simply aggradation occurs when the increase in sediment is not equally matched by an increase in flow or discharge conditions. There are two types of aggradation occurring in Wahkiakum distinguished by the type of hydrology: (1) Fluvial (river dominated) and (2) Tidal-fluvial (combination of estuarine and riverine forces).

**Fluvial-based aggradation** occurs when sediment material from high sloped, erodible areas in the upper areas of the watershed are mobilized and deposited in lower gradient reaches, overburdening the channels capacity to convey the existing flow regime. The flow then responds to the now limited area of the channel, sometimes directing itself into streambank walls or overtopping banks to reestablish its previous capacity. This can further compound aggradation by entraining new sediment into the channel. Wilson Creek (figure 3.19) had a fairly severe flooding issue in the early and mid 90's. The upper watershed had been logged off and there was mass slope failures resulting in extensive over bank flooding in the valley area. The system has stabilized as trees have grown back and slowed down delivery of sediment for the last five years. The most prominent examples of aggradation occurring in the County are

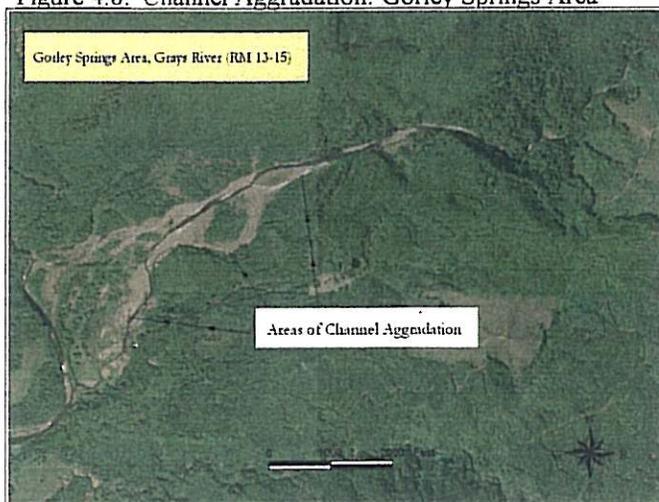
Figure 4.8: Channel Aggradation: Gorley Springs Area

around the Gorley Springs area (figure 4.8) where confined, higher energy channels, abruptly change into broader, low gradient sections whereby sediment material is deposited. This deposition area is dominated by medium sized, unconsolidated material that is used to form new channel networks as witnessed by the 1998 avulsion in this area. To date these areas is extremely unstable with flows patterns occupying multiple channels throughout a water year.

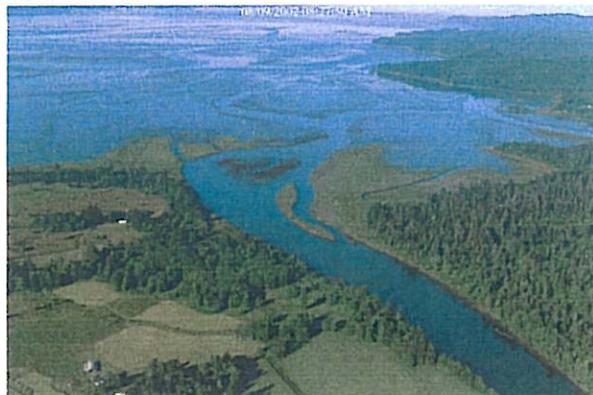
Figure 4.9: Mouth of Grays River

the embayments (i.e. Baker Bay, Young's Bay, Cathlamet Bay) of the Columbia River Estuary. This elevates the complexity of the issue to larger flow-sedimentary processes of the Columbia River Basin where the extent and degree of aggradation is highly variable in each embayment. However, it is along the embayments of Wahkiakum that aggradation is perceived to be contributing to flooding problems in each of the watershed areas, with the exception of Puget Island. The perception is that the accretion of areas like Grays Bay translates to the reduced capacity of the channel to convey or 'drain' a given discharge efficiently. In theory, reducing a channels area for a given flow can confine the active channel requiring a response in the channel direction to find a new channel that can contribute to overbank flooding and/or stream bank erosion.

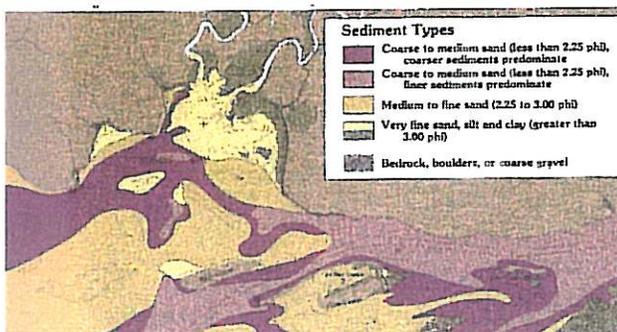
Figure 4-10: Grays Bay Sediment Types (CREST 1983)

In reality larger, watershed-scale factors influence the accretion patterns. These include: sediment source identification, flow patterns, sediment size distribution, and an understanding of the river-bay transition zone influenced by riverine and tidal dynamics. Man-made alterations in the form of pile diking, dredge material disposal, and hydro-modification also affect the depositional patterns in Grays Bay. Figure 4-10 shows depictions of the sediment distribution for the slough networks of Wahkiakum County based on information compiled by CREST in the 1980s (CREDDP, 1984). Generally speaking, areas with very fine grains reflect lower tidal-fluvial energy environments where lighter, smaller material is able to deposit. Alternatively, areas with coarser material demonstrate higher energy areas.

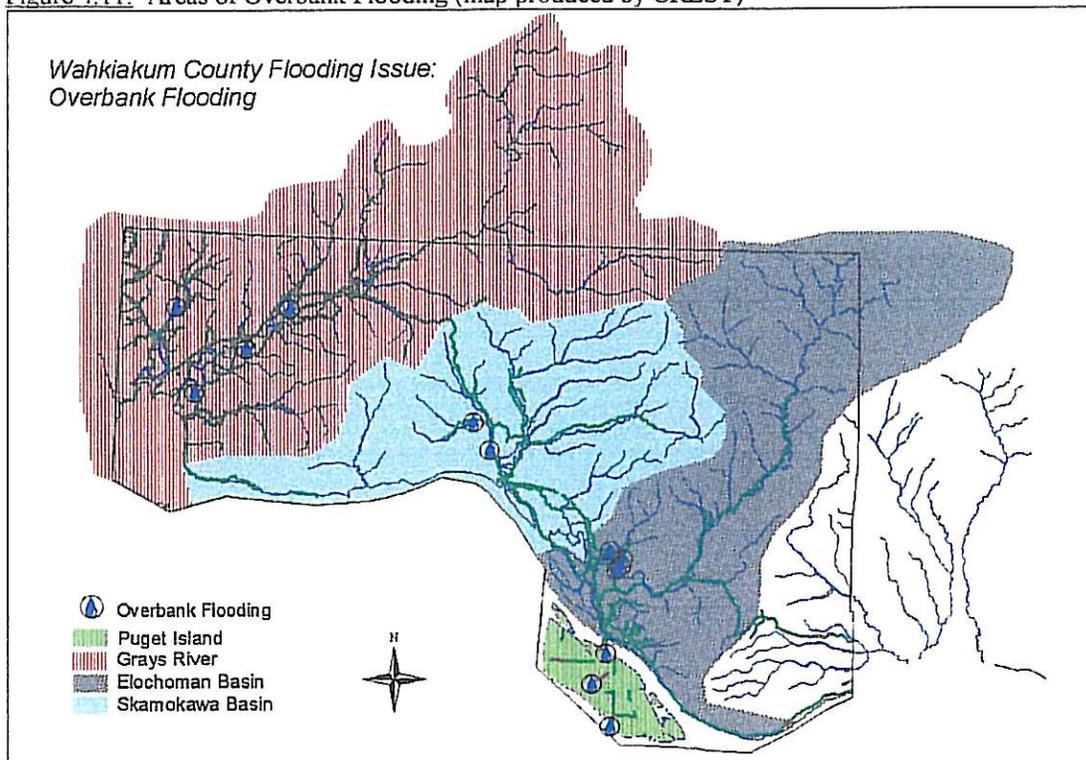
Figure 4.11: Areas of Overbank Flooding (map produced by CREST)

Overbank flooding is a natural process that a channel requires to reach equilibrium within its floodplain. It occurs when the elevation of the stream channel overflows its active channel and spills onto the floodplain. Unfortunately, it often occurs in lower gradient bottom areas of the County suitable for development, including private dwellings, farmland activities, and public access roads. Overbank flooding frequently occurs because of the combination of high flow events, with deteriorating maintenance of existing dike and public infrastructures such as roads. The situation is further exacerbated in tidal areas during bi-diurnal high tides and storm surges that can increase wave amplitudes. Diking can help minimize overbank flooding at the local level, however it can confine the natural tendency of the channel to move laterally increasing the chances of overbank flooding downstream. Another common cause of overbank flooding in the county is undersized culverts that do not possess the capacity to convey discharges during high flow events. Examples of this type of overbank flooding in Wahkiakum County include Altoona-Pillar Road in the Grays River Watershed, Foster Road (adjacent to Nelson Creek) in the Elochoman Basin, and the mouth of Birnie Creek in the Town of Cathlamet

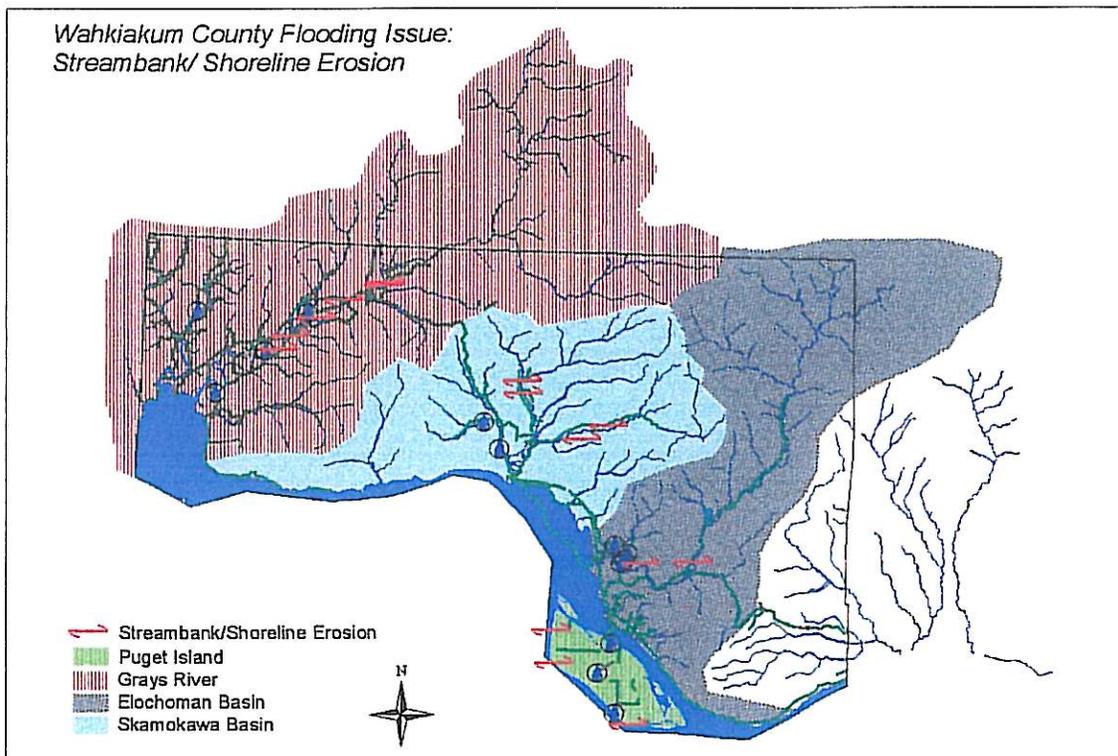
Figure 4.12: Areas of Streambank/Shoreline Erosion

Opposite of aggradation, erosion occurs when the stream banks wear away due to shear stress placed on it by stream energy velocities. Erosion is very common in the middle portions of the County's watersheds between the base of high gradient slopes and low gradient tidal areas. Large expanses of highly erodible soils combined with ground disturbing activities such as logging and road building can destabilize slopes and cause frequent slope failures. These mass movements often expose tracts of soil to direct rainfall further destabilizing the area and entraining sediment into Wahkiakum streams.

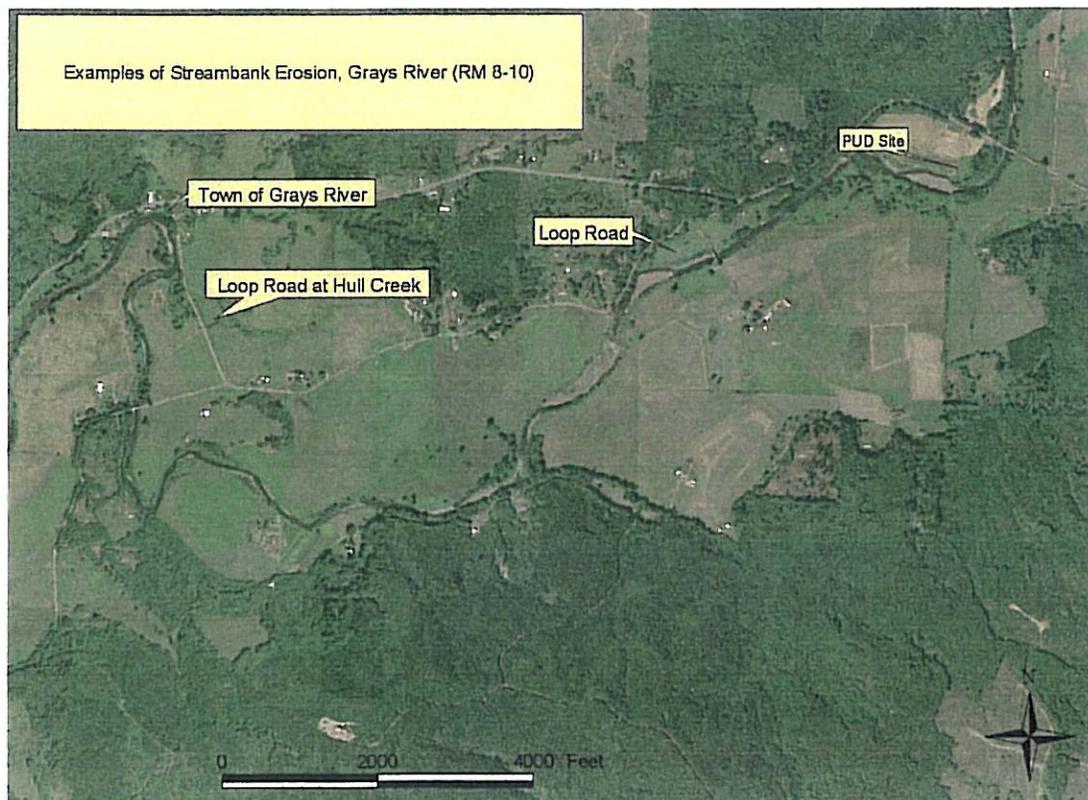
Figure 4.14: Streambank Erosion- Grays River

The assessment process directed ideas towards a list of conceptual design alternatives that identified specific erosional areas on the Grays River. While the report is not final at this time, planning, engineering, and permitting is moving forward to protect the PUD site downstream from the SR 4 Bridge on the Grays (figure 4.14). Using a combination of structural remedies and riparian plantings the District and StreamFix are moving forward to construct in the next year. Multiple areas along Loop Road have also been identified as areas impacted by erosional forces along the Grays River. Wahkiakum County has recruited the assistance of Army Corps of Engineers to assist with multiple sections of erosion that is endangering access on Loop Road, bridge supports, as well as private property.

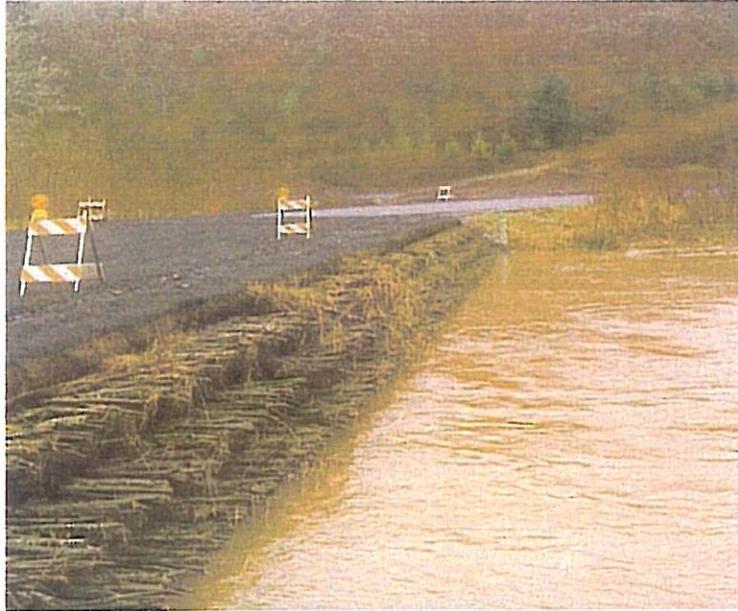
Figure 4.12: Middle Valley Streambank Erosion Project, Skamokawa Creek

A streambank project completed by the County in the Middle Valley portion of the Skamokawa watershed demonstrated a combination of plantings and geotextile material, this served the dual purpose of on site protection and the slowing down of, rather than the deflection of, erosive velocities. Results on the effectiveness of this project are inconclusive as erosion continues downstream from this site. Further project effectiveness monitoring may be needed to understand its full benefit and to inform necessary design modifications for future projects in the Skamokawa Basin.

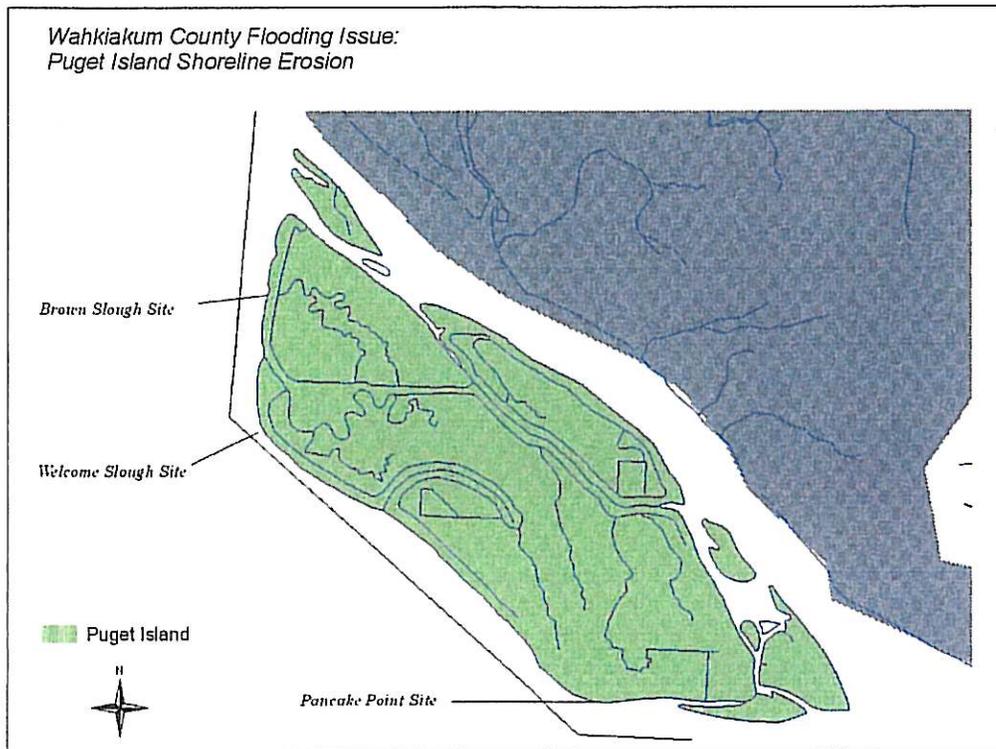
Figure 4.13: Areas of Shoreline Erosion Puget Island

Other types of erosion are occurring along Wahkiakum's shorelines. On Puget Island, the forces contributing to this erosion are directly related to structures and activities associated with the Columbia River navigation channel. Pile dikes and jetties along the channel were installed to direct flow velocities into the navigation channel to minimize maintenance of the existing channel configuration for transportation needs. The position and angle of these structures is such that they currently contribute to erosive forces along the Puget Island shoreline. A Technical Memorandum produced for the County by Coast & Harbor Engineering characterized the nature of the erosion and proposed several design alternatives (see Appendix F). According to the Memo, the erosion forces at the Welcome Slough and Pancake Point sites are in part due to the placement and orientation of pile dikes. Currently, several design alternatives are being discussed, including the placement of dredged material to protect the shoreline from further erosion. At the writing of this report, the County is working with CREST, Army Corps of Engineers and other permitting agencies to find feasible short term and long-term solutions for these areas. This will be discussed in further detail in Section VI of the plan.

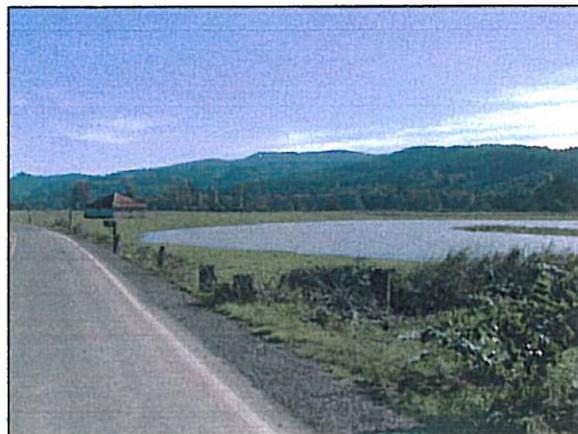
Figure 4.15: Localized Ponding: Grays River Area

In many of the valley-bottom lowlands, extensive ponding takes place that can be further compounded by any of the flood hazards identified above. This phenomenon is especially true of diked pasturelands that often maintain some of their native wetland soil structure. Wetland soils are characteristically poorly drained. Due to the common but sporadic occurrence of localized flooding, no areas of this type of flood hazard were identified on any map.
