# Technical Memorandum

## Bank Protection at Pancake Point and Welcome Slough, Puget Island

**Wahkiakum County**

October 31, 2003

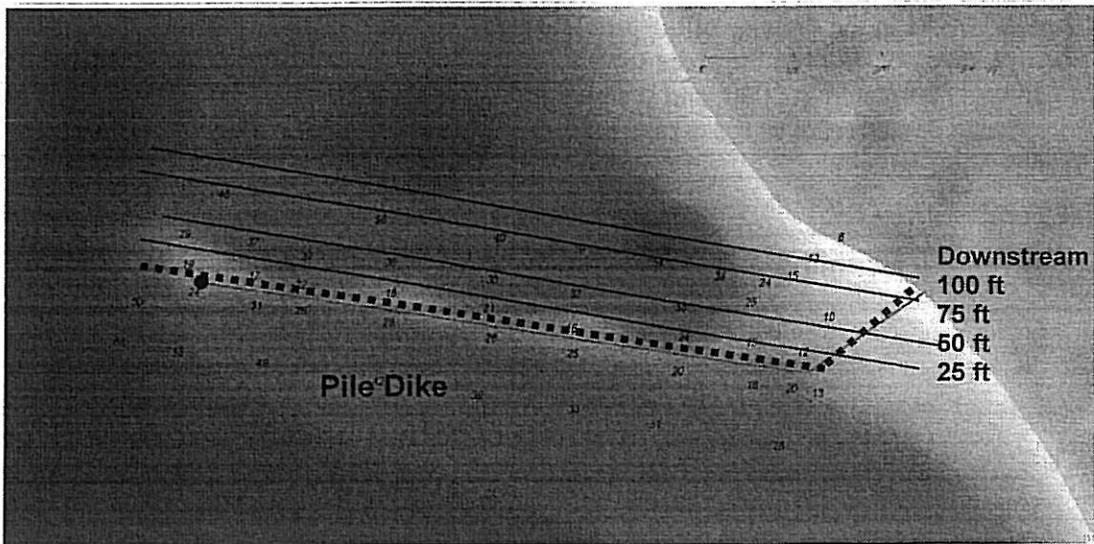
Figure 5 Location of cross sections used for bottom topographic analysis at Pancake Point

Bottom depths in the vicinity of the problem areas are not well documented. Cross line surveys have not covered the areas subject to erosion. A swath survey close to the pile dike 43.55 was completed in 2002, and is shown in Figure 4. Cross sections spaced at 25 feet increments downstream of the dike are shown in Figure 5. A sequence of 4 bottom profiles is shown in Figure 6.

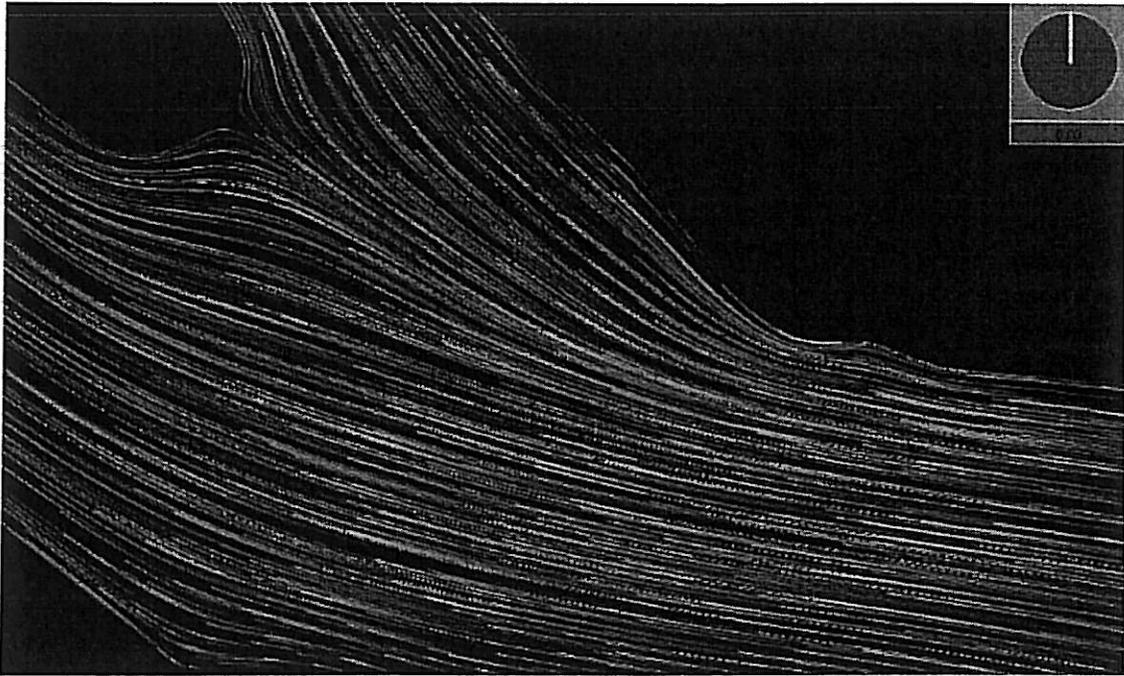
Figure 8 Flow pattern in approximated Wauna Reach without pile dikes

As a demonstration of possible effects of a pile dike on flow patterns, a generalized model of river flows was developed for two cases. One case represents a portion of the Wauna and Driscoll Ranges before pile dikes were constructed at Pancake Point. The second case represents the same location and river discharge with pile dikes in place. Model results of a 200,000-c.f.s. discharge and a dike having low porosity are shown in Figures 8 and 9. Comparison of the figures indicates that the pile dike at Pancake Point is capable of flow interference of the type that could create an eddy turning in the observed direction. Although the pile dike near Welcome Slough was not modeled with the generalized hydraulic model, cause-and-effect relationship of the presence of the pile dike and lack of
